Case Study: Overcoming Welding Challenges on Condenser Manifold

Project Summary:

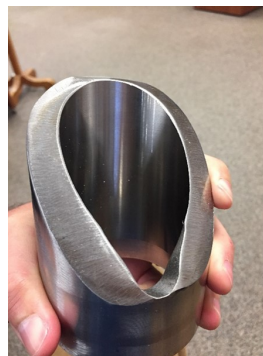
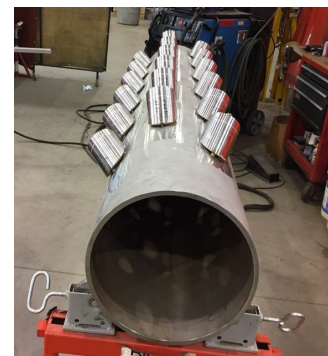
The complicated nozzle angles on the condenser manifold required engineering ingenuity

The condenser in a nuclear power plant turns the steam, that is used to generate power via a turbine, back into water (condensate) to be reused in the plant. A major part of the condenser is the condenser manifold which acts as a sparger to facilitate the cooling of the condensate. The condenser manifold consists of multiple drain branches (latrolets) which connect to the body of the manifold at complex angles (often 45°).

A North American nuclear plant needed to replace their existing condenser manifold and was having trouble finding a fabrication company to be able to handle the difficult welding between the latrolets and the main shell. Due to the 45° angle on the latrolets they and the shell are prone to warping and distortion during the welding process. This would result in misalignment when installing the manifold into the plant.

Energy Steel engineers devised a series tooling and temporary attachments to ensure that the welded latrolets and shell would not distort during the welding process. This included attaching each of the latrolets together in rows and using non-welded attachments on the inside of the shell. A series of test welds were carried out to prove the process prior to welding.
